# Stairway Falls

*An ergonomics analysis of 80 cases*

**By Joseph Cohen, Cindy A. LaRue and H. Harvey Cohen**

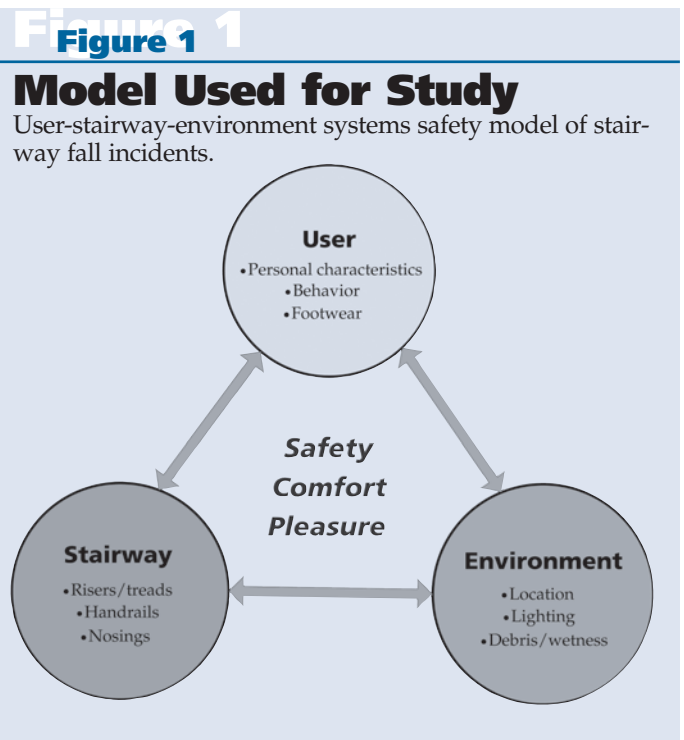
The ergonomics-based systems safety model adopted in this research served as a conceptual framework for analyzing the 80 cases (Figure 1). In systems thinking, one assumes a dynamic and interactive relationship between the elements involved in the use of a stairway—namely the user, stairway and environment of use. Harmony between the elements ensures positive outcomes when using stairways—namely safety, comfort and pleasure.

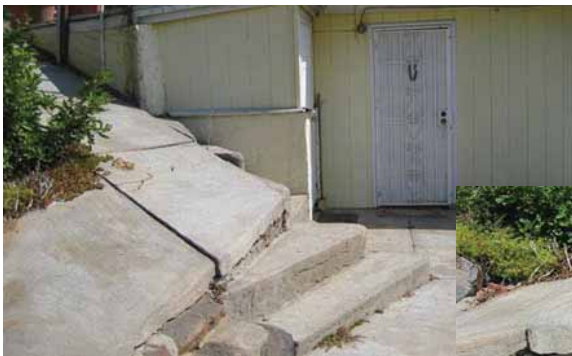
**Photo 1:** This stairway has high degree of variation in both riser heights and tread depths. If a riser is too high or too low, a person navigating the stairs may find it difficult to maintain safe footing. Treads that are too short force the stair user to either rest only part of a foot on each tread or to twist the foot unnaturally.

highest measured 10.375 in. For the most part, the risers in this investigation ranged from 5 to 7.5 in. The treads in this investigation ranged from 8 to 35 in., with the treads of most of the staircases falling between 10 and 12 in. Photo 1 shows a stairway with a high degree of variation in both riser heights and tread depths. The top tread narrows down to 2 in. on the far left side. This extreme dimensional variation, combined with the excessive slope of the walking surface, lack of a handrail and insufficient lighting created a very unsafe stairway.

Sixty percent of the stairs in this study were found to have riser variations of greater than 0.375 in. The greatest variation was a stairway with a 6-in. variation in the riser heights. The average riser variation for the investigated cases was approximately 0.625 in., a full quarter-inch more than the amount of variation allowed by the model codes. Explanations for these variations include the natural settling during the life of the staircase, poorly maintained structures and conformance to fit existing sidewalk or terrain, as well as design and construction flaws.

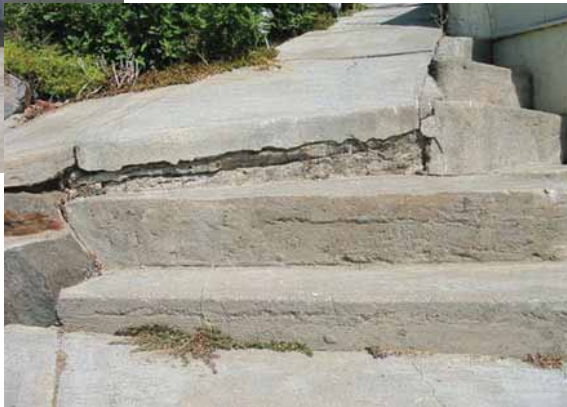
**Photo 2:** This half-round stair has an unusually long tread. The step edges could be made more conspicuous with hazard yellow striping and an intermediate handrail. Also note the deceptive visual cues created by nearby expansion joints, and the adjoining ramp handrail (to the right) which is excessively long.

Photo 2 depicts the stairway in question. The half-round stair has an unusually long tread (35 in.), the edge of which was not conspicuously marked with, for example, hazard yellow striping. The lack of an intermediate handrail more within the normal line of sight also was considered to be a contributing factor to the injury incident. Such a handrail would have provided a more obvious visual cue to the subtle change in elevation.

Deceptive visual cues, including the presence of expansion joints that blend in with the grooves along the step edges, as well as an exceptionally long handrail to the right (as one descends the stairway) and one bordering the left edge of an adjoining ramp, were also implicated as contributing factors.
